## OREGON CORNER RESTORATION FORM Section: 4, 5, 32, 33 Township: 3N, 4N County: Umatilla Date: 3/24/2011

3N33A09

Section corner common to Sections 4, 5, T3NR33E; 32, 33, T4NR33E.

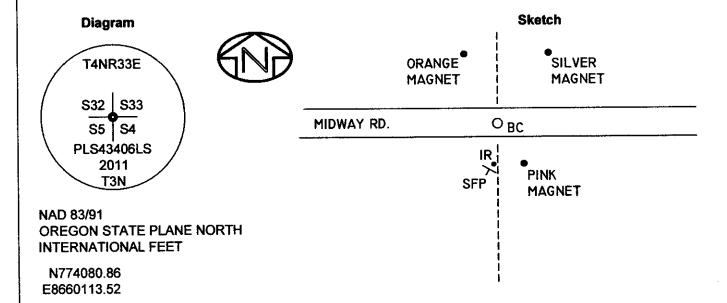
Monuments and Accessories Found: (Condition and Source):
None.

A 1 1/8" x 30" galvanized iron pipe with a 2 1/2" brass cap, stamped as shown above, 1.0' below the surface. The corner location was reestablished at the intersection of the line between neighboring corners East and West and the projection of field lines from the North and South and from old fence corner posts to the South.
