OREGON CORNER RESTORATION FORM

Section: 7, 8 Township: 3N Range: 33E
County: Umatilla Date: 5/24/2011

Corner Designation: 3N33G05

Quarter corner common to Sections 7, 8, T3NR33E.

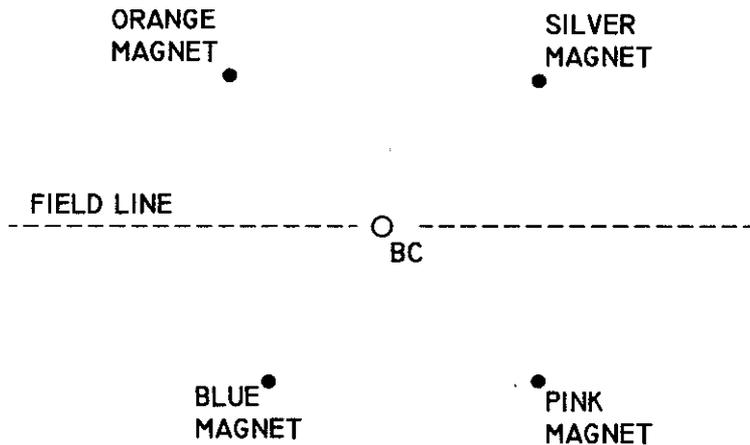
Sketch

None.

A 1 1/8" x 30" galvanized iron pipe with a 2 1/2" brass cap, stamped as shown above, 1.2' below the surface. Location of corner was reestablished by holding the North-South line between found corners and by holding a long established East-West plow berm which fell 6', more or less, South of the single proportioned Northing.

- "Deep One" magnets by Berntsen.
- An orange magnet lies N 44° 45' W, 22.43', 1.3' deep.
- A silver magnet lies N 47° E, 21.90', 1.4' deep.
- A pink magnet lies S 45° E, 22.77', 1.2' deep.
- A blue magnet lies S 36° 30' W, 19.15', 1.1' deep
