CORNER RESTORATION FORM

Township 4N Range	28E	_Section	13, 24	County	UMATILLA
State OREGON Date	5-20-2019	_Number	N-23		
Corner Designation:	13, 24			:	Condition Report Only
Previous Renewals ORIGINAL SOURCE OF CORNER ORIGINALLY				Y .	Not Found
SURVEYED IN 1860 BY HAFT UNDER CONTRACT #93, HE SET POST IN MOUND WITH				WITH	Renewed
TRENCH, MADE PITS AND DEPOSITED A PINT OF CHARCOAL.					Surveyed In
					X Referenced
Accessories Found:					MONUMENT DETAIL
FOUND 2 1/2" BRASS CAP WITNESS CORNER, LS 951, N00° 36' W 33.00, AS PER COUNTY				OUNTY	X Found Set
SURVEY NO. 89-086-B.					
FOUND 5/8" IRON REBAR WITH PLASTIC CAP MARKED LS 951, BENT TO THE SOUTH, S00°				OUTH, SOO°	
49' E 33.21 FT, AS PER PP 1994-17,					
BASIS OF BEARINGS, NAD 83/91 OREGON STATE PLANE COORDINATES NORTH ZONE: NORTHING: 787601.05 EASTING: 8518473.78					UMREADABLE

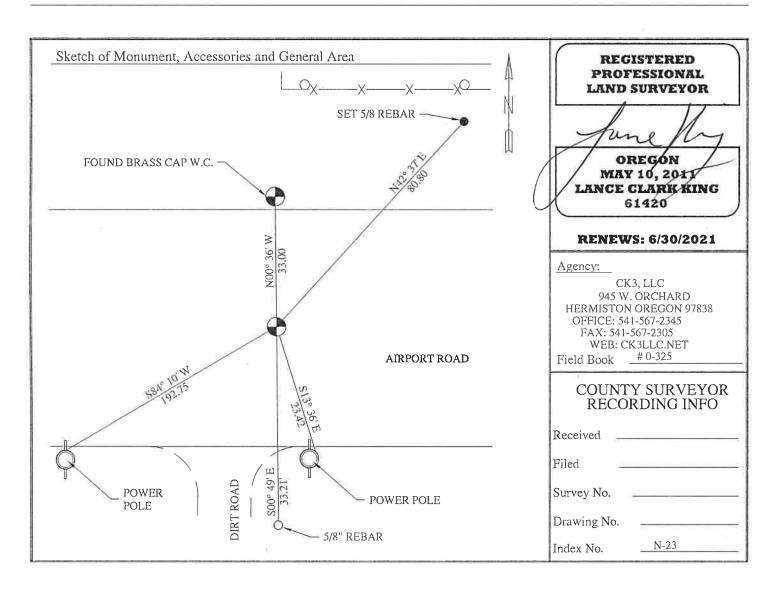
FOUND 2 3/8" BRASS CAP NEAR CENTER OF ROAD AS PER COUNTY SURVEY NO. 89-086-B,

SET 1 1/2" STEEL WASHER AND NAIL IN POWER POLE APPROXIMATELY 2' ABOVE GRADE, S84° 10' W 192.75 FT.

SET 1 1/2" STEEL WASHER AND NAIL IN POWER POLE APPROXIMATELY 2' ABOVE GRADE, S13° 36' E 23.42 FT

SET 5/8" X 10" REBAR W/ RED PLASTIC CAP MARKED PLS 61420, 1 SOUTH OF THE EASTERLY GATE POST OF CHANLINK FENCE AND 1' DEEP, N42° 37' E 80.80 FT.
