OREGON CORNER RESTORATION FORM				<u> </u>
Section County	7Township UmatillaDate:	December 24, 2009	32E	_
Corner De	esignation: 1N32G5			Condition Report Only Not found
Quarter corner common to sections 7 and 8, T1N, R32E, W.M., Umatilla County, Oregon.			x	_Remonumented Unrecorded _Surveyed in
	Renewals / Surveys, etc		X	_Referenced out

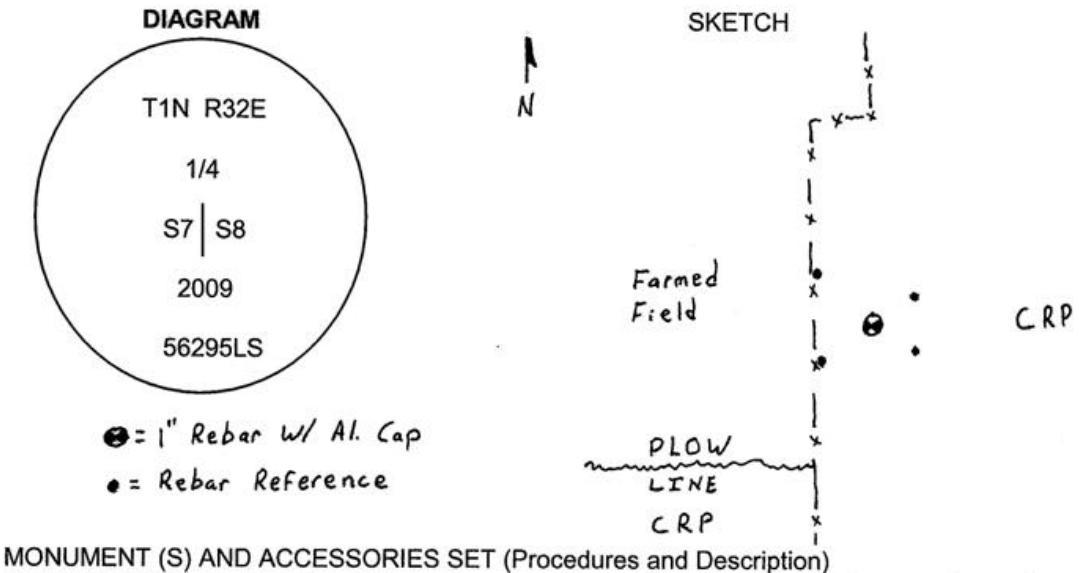
Monument and Accessories found: (condition and source) None. The point falls in a plowed field.

I set a 1" x 24" iron rebar with a 2" aluminum cap stamped as shown in the diagram above at the proportioned point. The rebar is driven 14" into the bedrock and the cap is 20" below the surface of the field.

For references, I set four 5/8" by 24" iron rebars with 1 1/4" orang plastic caps stamped WTS and 56295LS as described below:

an iron rebar bears N38°11'30"W, 53.36 feet in the existing fence; an iron rebar bears N45°50'55"E, 44.74 feet 20 inches below the surface of the field; an iron rebar bears S53°34'50"E, 53.33 feet 20 inches below the surface of the field; an iron rebar bears S36°31'26"W, 58.22 feet in the existing fence;
