OREGON CORNER RESTORATION FORM						
Section County	16 Umatilla	Township Date:	1N December		32E	
Corner Designation: 1N32N11					Condition Report Only Not found	
Quarter corner common to sections 16 and 21, T1N, R32E, W.M., Umatilla County, Oregon.					X	Remonumented Unrecorded Surveyed in
1111, 11021	_,,	iatina oounty,	orogon		'x	_Referenced out

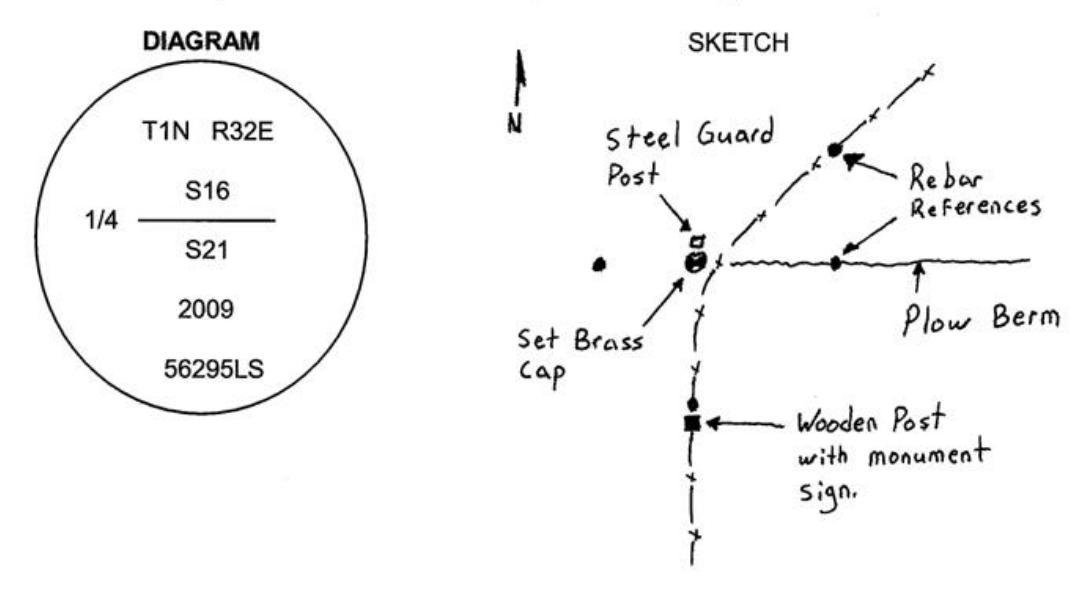
A fence line running south and northeast and a plow berm running east.

MONUMENT (S) AND ACCESSORIES SET (Procedures and Description) At the intersection of the fence to the south and the plow line east I set a 1 1/2"x30" galvanized iron pipe with a 2 1/2" brass cap stamped as shown in the diagram above.

For references, I set four 5/8" by 24" iron rebars with 1 1/4" orange plastic caps stamped WTS and 56295LS as described below:

an iron rebar bears N89°51'02"W, 63.96 feet 2 feet below the surface; an iron rebar bears N31°46'13"E, 57.53 feet under the existing fence; an iron rebar bears N89°44'58"E, 94.34 feet 2 feet under the surface; an iron rebar bears S01°54'44"E, 96.33 feet under the existing fence;
