OREGON CORNER RESTORATION FORM

Section 6 Township 5S Range 31E
County Umatilla Date: 11-28-01

Corner Designation: 5S31A1

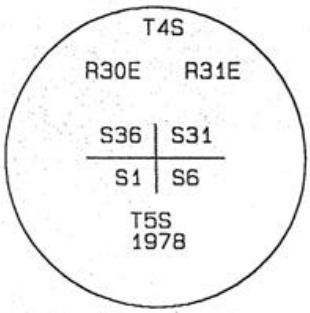
DIAGRAM

Under Special instructions dated May6, 1957, Craig Wanless of the BLM replaced the original stone with a BLM brass cap stamped as shown in the diagram. He set two new bearing trees;

Found the brass cap as described. Found: A sawed pine stump N50°E, 35.6'; a sawed pine stump S33°E, 77.9'; a 21" ponderosa pine S70°W, 25.7'; a high stumped 29" pine bears N80°W, 52.8'; a 10" ponderosa pine bears N34°E, 18.2'; a 12" ponderosa pine bears S52 1/2°E, 20.5'
