OREGON CORNER RESTORATION FORM

Section:	28, 29, 32 & 33					
Township:	6 North					
Range:	34 East of the Willamette Meridian					
County:	Umatilla					
Date:	June 1, 2002					
Corner Indexing Information:		Township 6N	Range 34E	Corner Code	V 9	(Willamette Meridian)

This corner is common to sections 28, 29, 32 & 33.

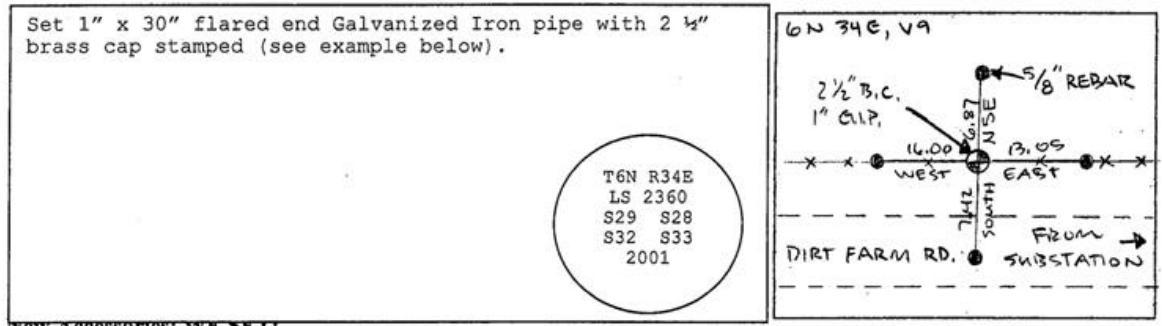
Monument Detail:

At the southwest corner of section 28, T6N R34E, found a 2"x54" iron pipe at the surface in east-west fence line.

A 5/8 rebar with yellow plastic cap stamped 'Tomkins Surveying' which bears East ~ 13.05 feet A 5/8 rebar with yellow plastic cap stamped 'Tomkins Surveying' which bears East ~ 13.05 feet from the corner. Attached a Umatilla County Bearing Object Sign to Southwest face of the Locust Fence Post. A 5/8 rebar with yellow plastic cap stamped 'Tomkins Surveying' which bears South ~ 7.42 feet from the corner. No steel t-post set or a Umatilla County Bearing Object Sign A 5/8 rebar with yellow plastic cap stamped 'Tomkins Surveying' which bears West ~ 16.00 feet from the corner. Attached a Umatilla County Bearing Object Sign to Southeast face of the Locust Fence Post. A 5/8 rebar with yellow plastic cap stamped 'Tomkins Current of the Locust Fence Post. A 5/8 rebar with yellow plastic cap stamped 'Tomkins Surveying' which bears N 5°E ~ 6.87 feet from the corner. No steel t-post set or a Umatilla County Bearing Object Sign. Location & Comments:
