USDA-FOREST SERVICE

**CORNER RECORD (SEARCH)**

T 2S R. 35E

LAND CORNER RECORD

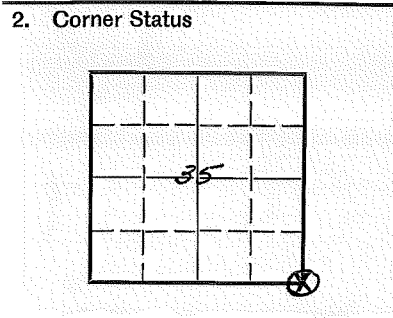
4. Description of Corners: POST 4 1/2' LONG, 5" Sq. 2' INGROUND TO SEC. COR.  
FROM WHICH: A PINE 15" DIAM BEARS S50°E 55 LKS DIST.  
A TAMARACK 20" DIAM BEARS N56°W 30 LKS DIST  
A PINE 26" DIAM BEARS S34°W 67 LKS. DIST.  
A TAMARACK 6" DIAM, BEARS N60°E 81 LKS DIST.

5. Investigation Notes: L.P. TREE 4" DB.H.  
GOOD CONDITION.  
GLAZED ALL 4 SIDES.  
B.T. WL, 13" DB.H., 13' DIST. BRS. N. 42°E,  
ALIVE WITH VISIBLE SCRIBING T.25, R.35E, S.36.  
B.T. P.P. (APPARENTLY) DOWN SNAG, ROTTED, WITH VISIBLE  
SCRIBING: (S.E. B.T.) 34' (APPROX) BRS. S.40°W.  
W.F. SNAG, DOWN & ROTTING, SCRIBING UNDER TREE,  
VISIBLE, 25' (APPROX) BRS. N.27°W.  
COR. IS ON SHORT RIDGE BETWEEN TWO SMALL  
DRAINAGES - NEXT TO OPENING ON THE SOUTH.
